# Manhole Inspection Summary

Manhole # S33OO\_031MH

Insp Date: **4/23/07 12:30 PM**

**Location** Address: **2410 CHARLES ST**

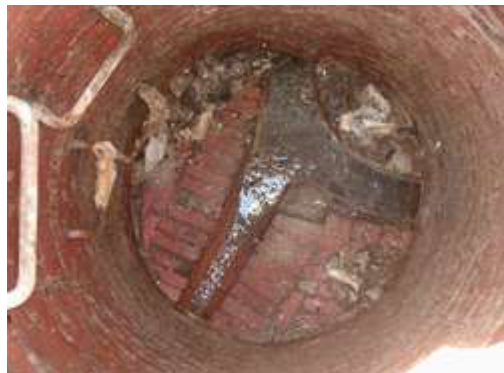
Top View

Corroded steps. Evidence of surcharge - Bench debris. Channel debris.

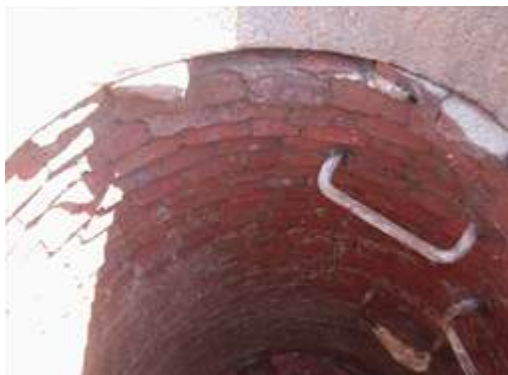
Defect

Condition: ☐ Sound ☐ Cracked ☐ Root Intrusion ☒ **Loose Brick** ☒ **Deteriorated**

Infiltration: ☐ None ☒ **Joint** ☐ Cracks ☐ Mortar ☐ Roots ☒ **Wall**

Adjustment deterioration, loose brick and infiltration. Barrel infiltration.

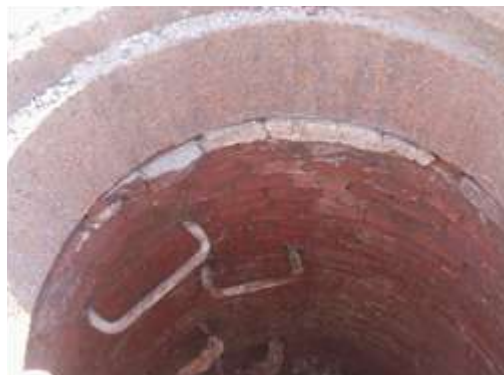
Defect

Adjustment deterioration and infiltration. Barrel infiltration.

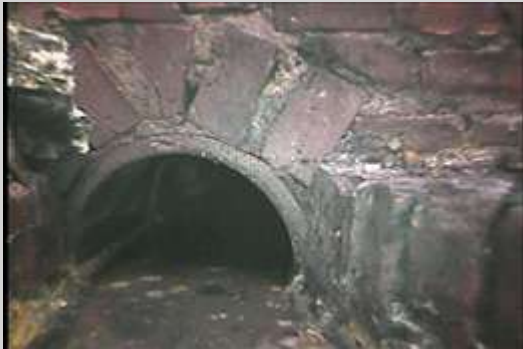
### 8 in. Circular Gravity Sewer Pipe Out @ 12 O'Clock

Deposits: ☐ None ☒ **Mud** ☐ Sludge ☒ **Debris** ☐ Grease

Silt Depth: **1** (in.) Deposits Extent: **Light**

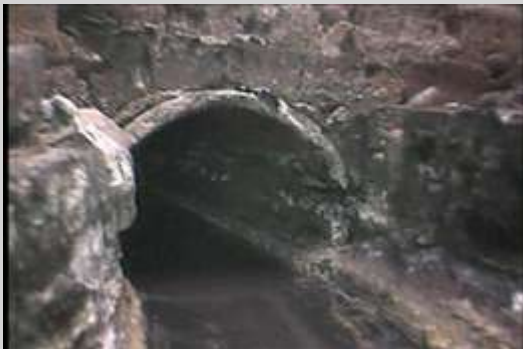
### 8 in. Circular Gravity Sewer Pipe In @ 3 O'Clock

Deposits: ☐ None ☒ **Mud** ☐ Sludge ☒ **Debris** ☒ **Grease**

Silt Depth: **0** (in.) Deposits Extent: **Light**

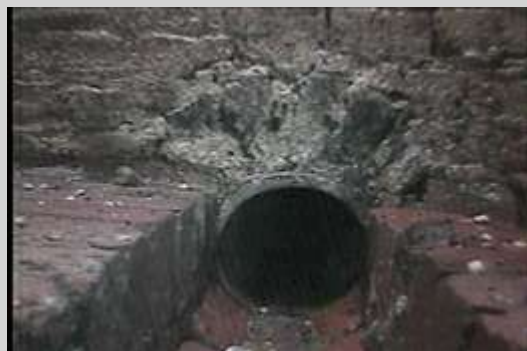
Pipe In @ 7 O'Clock

Barrel deterioration and infiltration.
